Re: Menefee Mining Corporation, Cuba Humate Production Facility; Unpermitted MSGP; SIC 1499, 1479 and/or 2879; NPDES Compliance Evaluation Inspection; NMU001887; March 4, 2015

Menefee Mining Corporation – Cuba Humate Production Facility
Compliance Evaluation Inspection
NPDES Permit No. NMU001887
March 4, 2015

Further Explanations

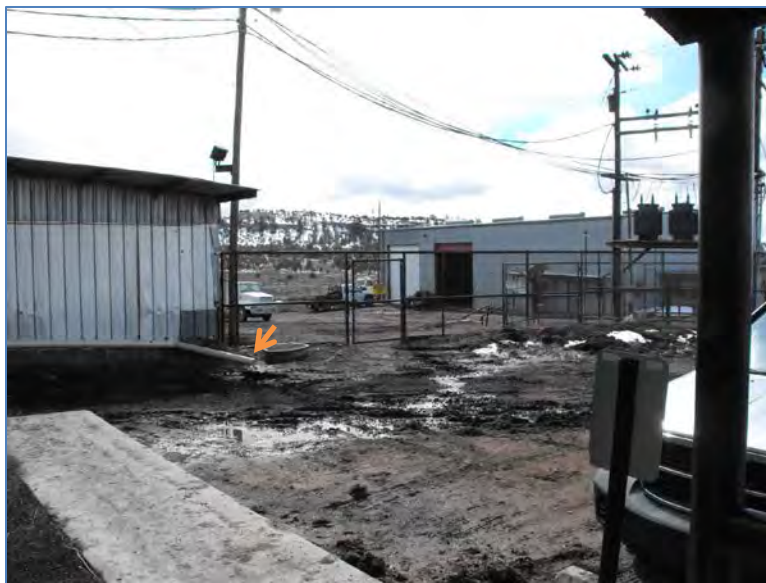
NMED/SWQB Official Photograph Log Photo # 1		
Photographer: Daniel Valenta	Date: 03/04/2015	Time: ~1304 hours
City/County: Cuba / Sandoval County		State: New Mexico
Location: Menefee Mining Corporation, Cuba Humate Production Facility		
Subject: Arrow points to pipe outlet. Overflow from filing water tanks inside building flows onto ground surface at this outlet according to Mr. Valdez.

On the day of this CEI (see photos), the site had processing and raw materials storage industrial activities, including outside storage and stockpiling of materials (e.g., overburden, raw material, intermediate products, finished products, byproducts and/or waste products) and material handling that would come into contact with stormwater from humate milling and preparation. Observed chemicals that are blended with the humate were within covered buildings on the day of this CEI. Vehicle fueling and maintenance occurs on site. Vehicle maintenance activities appeared to be within covered buildings on the day of this CEI. Overflows (non-stormwater) from the water soluble operation drinking water tanks are collected, then piped (gravity flow) outside the building on the ground surface.

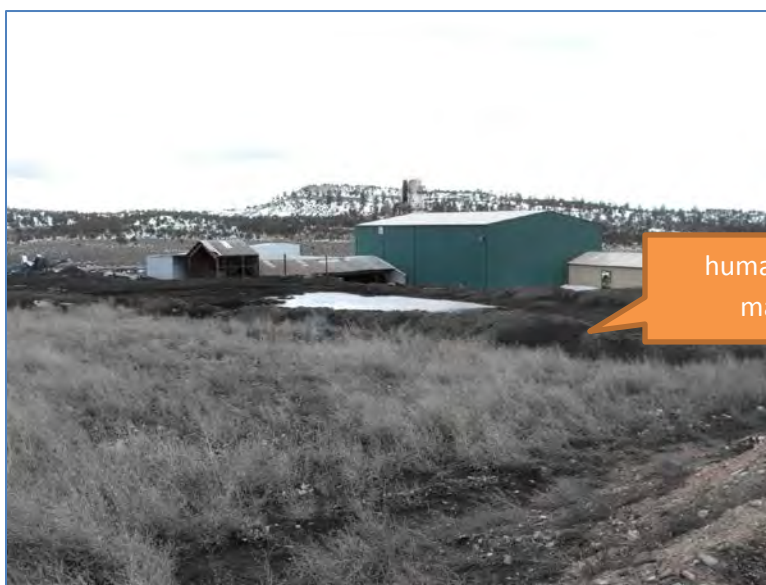
NMED/SWQB Official Photograph Log Photo # 2		
Photographer: Daniel Valenta	Date: 03/04/2015	Time: ~1312 hours
City/County: Cuba / Sandoval County		State: New Mexico
Location: Menefee Mining Corporation, Cuba Humate Production Facility		
Subject: Looking south-southwest at humate waste material according to Mr. Valdez in the northeast portion of the facility. In foreground, vegetation is growing on humate waste material.

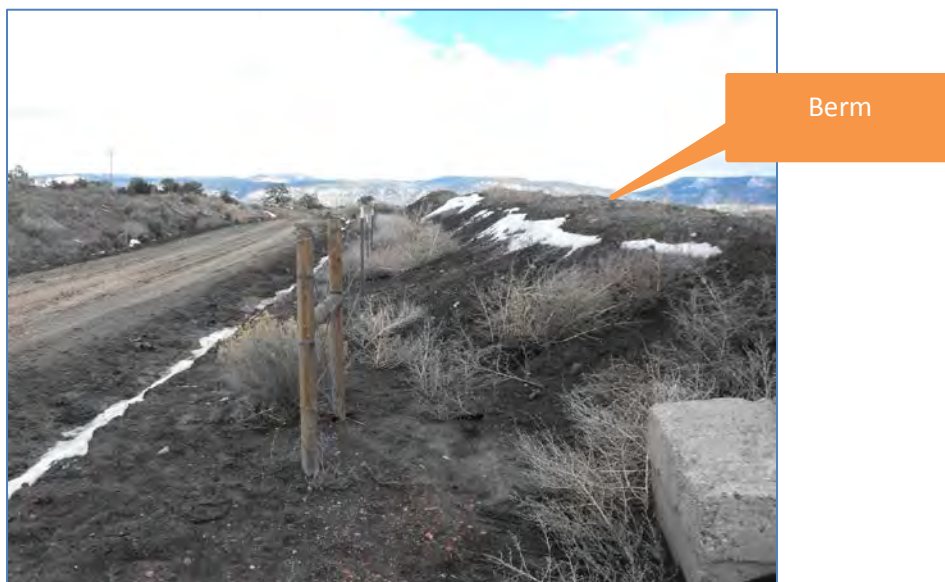
NMED/SWQB Official Photograph Log Photo # 3		
Photographer: Daniel Valenta	Date: 03/04/2015	Time: ~1314 hours
City/County: Cuba / Sandoval County		State: New Mexico
Location: Menefee Mining Corporation, Cuba Humate Production Facility		
Subject: Berm on facility side of Duke City Road appears to be made of humate waste material. Berm was installed to minimize stormwater run onto the facility.

The portion of the dirt Duke City County Road from NM 11 to the facility's entrance is maintained (graded) by Menefee Mining Corporation. Berms existed along the northern facility boundary along the Duke City Road to minimize stormwater run on according to the Mr. Valdez and Ms. Vandenburg. The berms appear to be humate waste materials and could be a source of potential pollutants along the county road roadway ditches. South-southwest west of outside processed humate material and waste humate storage, an earth berm collects runoff. The earth berm also collects upland and upstream water in the watershed. Mr. Valdez and Ms. Vandenburg did not know the design size or amount of water that could be collected by the earth berm in the south-southwest portion of the facility.

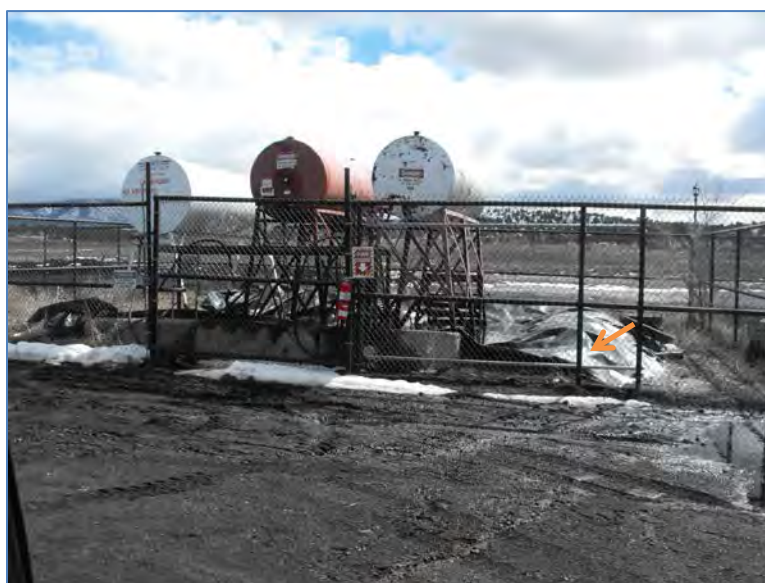
NMED/SWQB Official Photograph Log Photo # 4		
Photographer: Daniel Valenta	Date: 03/04/2015	Time: ~1318 hours
City/County: Cuba / Sandoval County		State: New Mexico
Location: Menefee Mining Corporation, Cuba Humate Production Facility		
Subject: Arrow points to liner beneath aboveground fuel storage tanks. Humate covered ground surface.

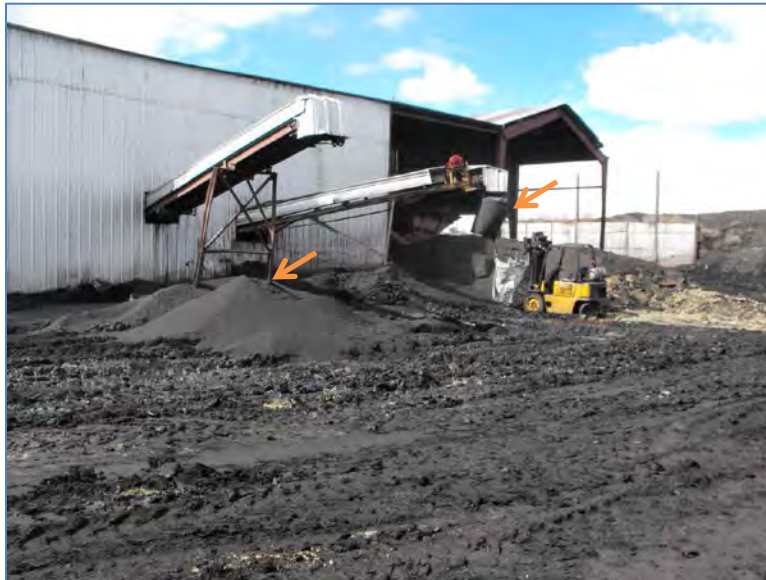
NMED/SWQB Official Photograph Log Photo # 5		
Photographer: Daniel Valenta	Date: 03/04/2015	Time: ~1320 hours
City/County: Cuba / Sandoval County		State: New Mexico
Location: Menefee Mining Corporation, Cuba Humate Production Facility		
Subject: Arrows point to stockpiles of finer screened humate material product beneath conveyer and bagging operations. Humate covered ground surface.

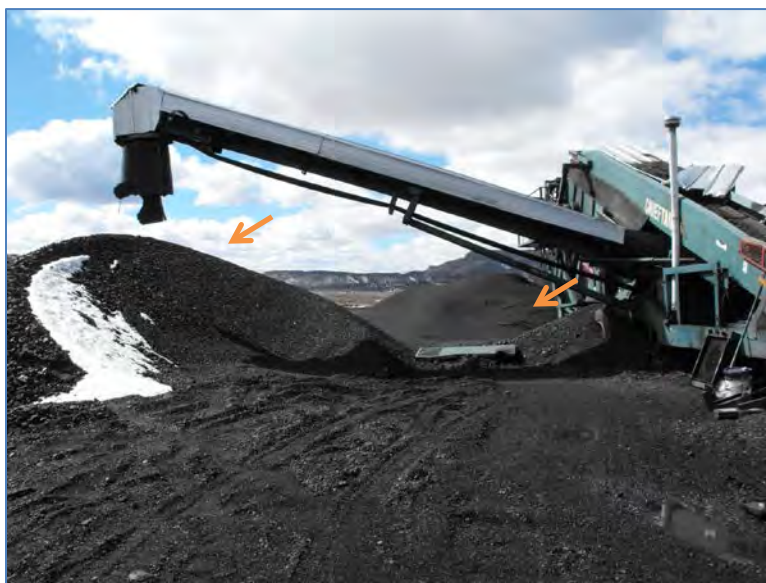
NMED/SWQB Official Photograph Log Photo # 6		
Photographer: Daniel Valenta	Date: 03/04/2015	Time: ~1322 hours
City/County: Cuba / Sandoval County		State: New Mexico
Location: Menefee Mining Corporation, Cuba Humate Production Facility		
Subject: Arrows point to stockpiles of finer and coarser screened humate material product. Humate covered ground surface.

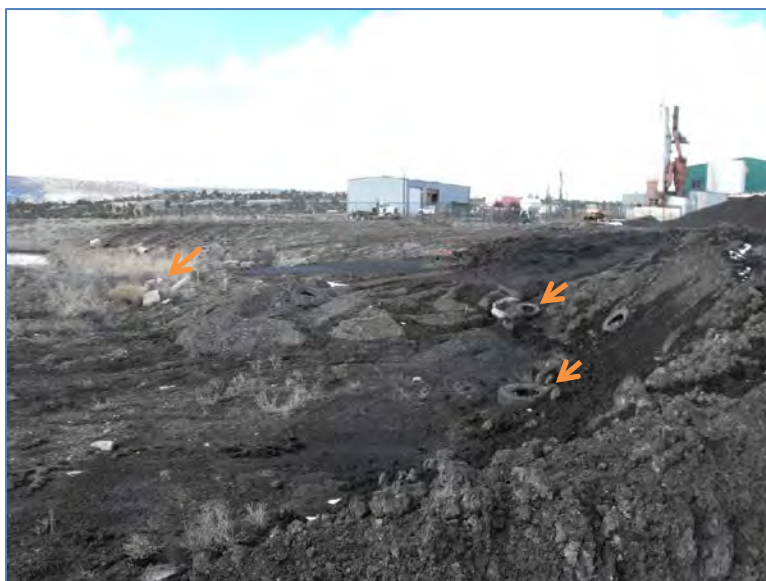
NMED/SWQB Official Photograph Log Photo # 7		
Photographer: Daniel Valenta	Date: 03/04/2015	Time: ~1328 hours
City/County: Cuba / Sandoval County		State: New Mexico
Location: Menefee Mining Corporation, Cuba Humate Production Facility		
Subject: Arrows point to examples of concrete debris and tires in humate waste material.

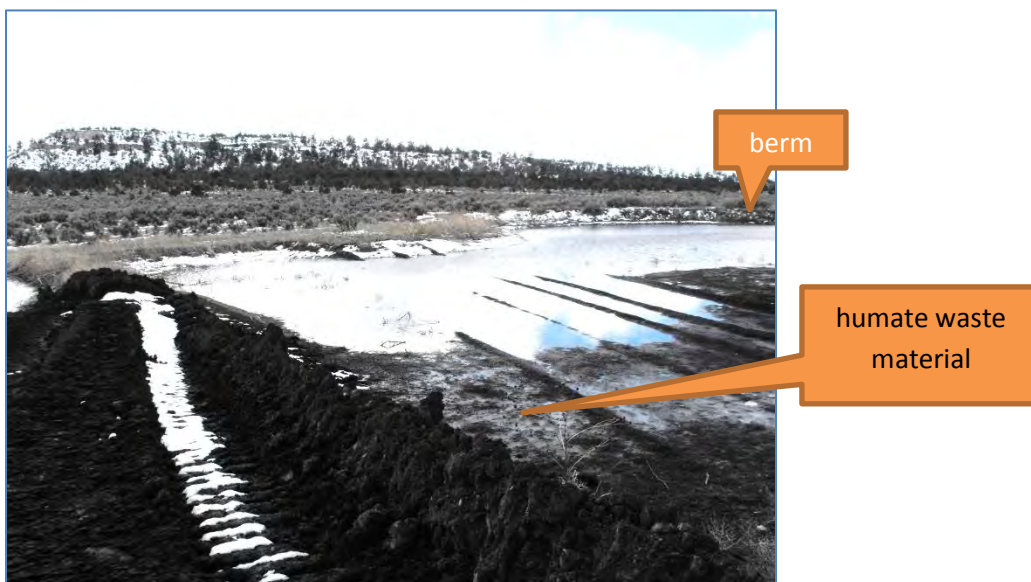
NMED/SWQB Official Photograph Log Photo # 8 (Brightness increased 30%, Contrast increased 20%)		
Photographer: Daniel Valenta	Date: 03/04/2015	Time: ~1329 hours
City/County: Cuba / Sandoval County		State: New Mexico
Location: Menefee Mining Corporation, Cuba Humate Production Facility		
Subject: Water collected upgradient of berm in south-southwest portion of facility. Humate waste materials exist in pond area.

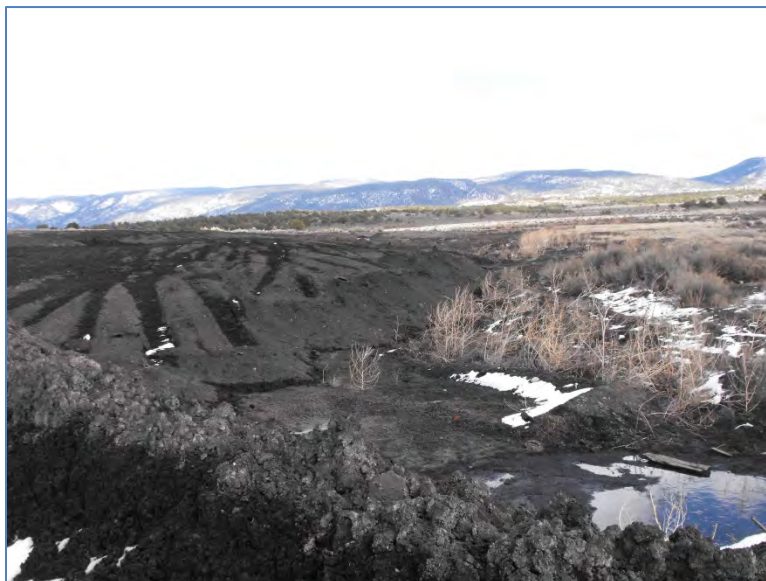
NMED/SWQB Official Photograph Log Photo # 9		
Photographer: Daniel Valenta	Date: 03/04/2015	Time: ~1330 hours
City/County: Cuba / Sandoval County		State: New Mexico
Location: Menefee Mining Corporation, Cuba Humate Production Facility		
Subject: Looking generally east, edge of humate waste material and vegetation in southern portion of facility.

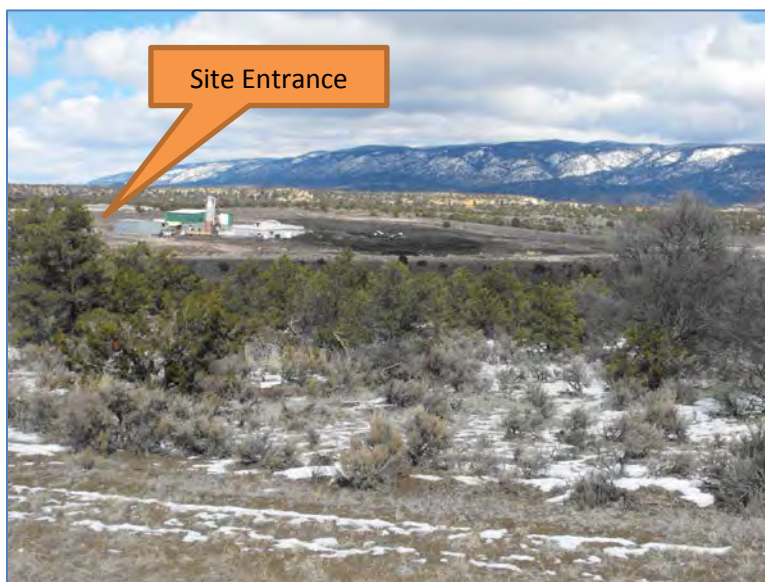
NMED/SWQB Official Photograph Log Photo # 10		
Photographer: Daniel Valenta	Date: 03/04/2015	Time: ~1340 hours
City/County: Cuba / Sandoval County		State: New Mexico
Location: Menefee Mining Corporation, Cuba Humate Production Facility		
Subject: From Hwy 11 approximately 0.25 miles southwest, looking north-northeast at overview of facility.
